SAN NICOLAS ISLAND BARGE LANDING SITE SURVEY

FPO-1-79(3)
NOVEMBER 1978

OCEAN ENGINEERING AND CONSTRUCTION PROJECT OFFICE
CHESAPEAKE DIVISION
NAVAL FACILITIES ENGINEERING COMMAND
WASHINGTON, D.C. 20374

Pacific Missile Test Center
Point Mugu, California

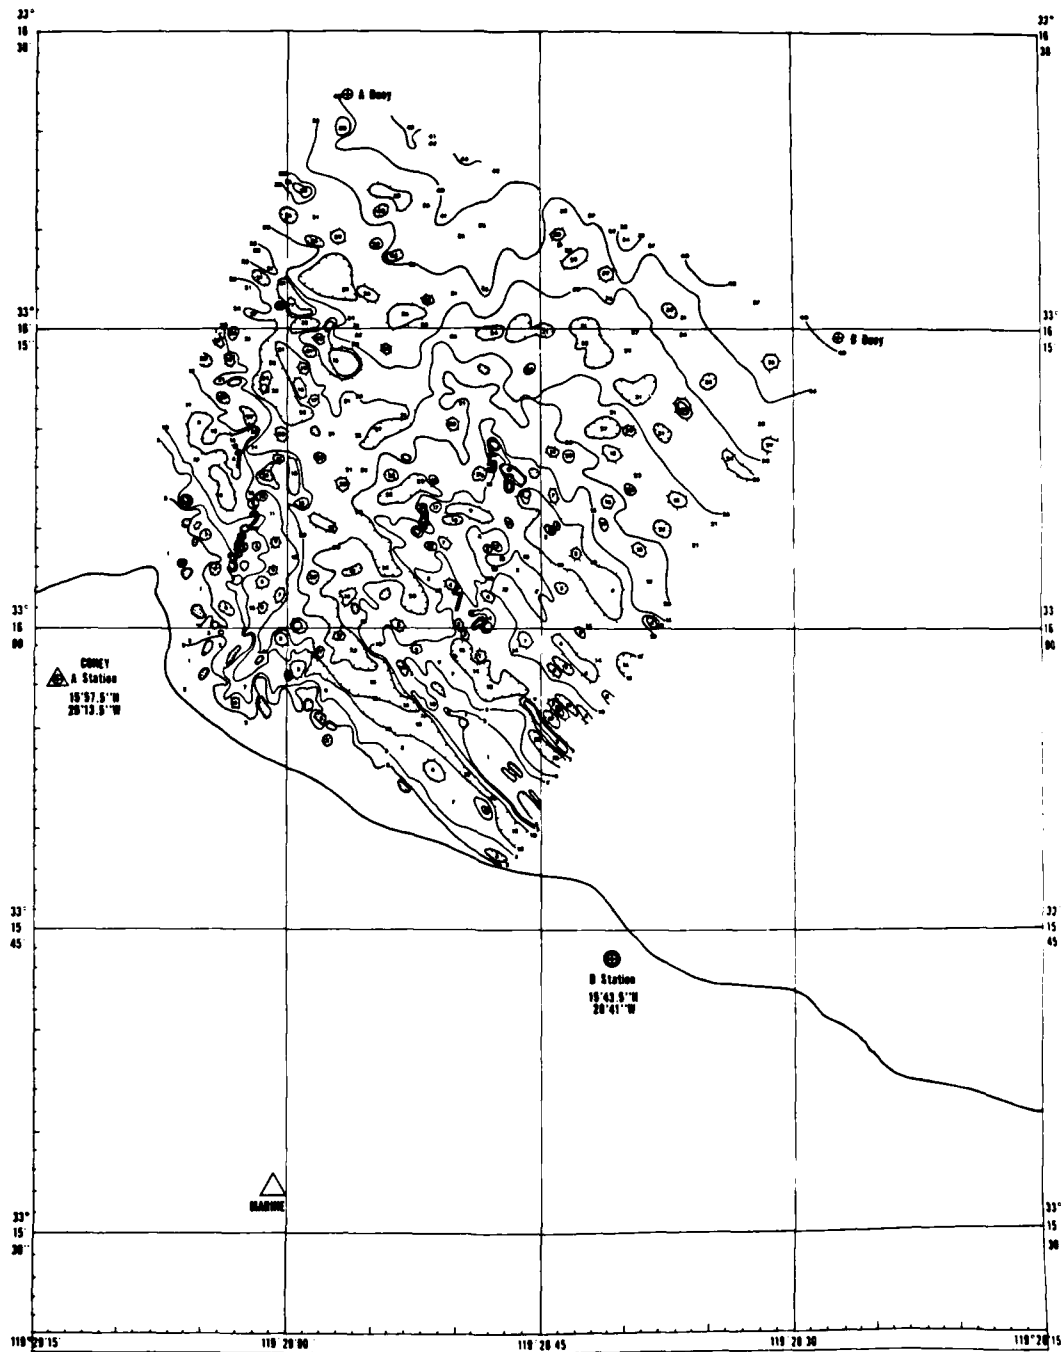
Figure 3. Depth Contour Chart - (Composite, Small)

③ Have problem w/ bathymetry charts - no contour identification, i.e. meter, feet, fathom etc. Fig. 3, 4, and big charts in appendix. Text indicates feet, however, when appendix is separated from text, the measure is lost.

④ Fig. 13 refers to non-existing contour intervals. Fig. 3 doesn't discuss "its" contours and is not very legible.

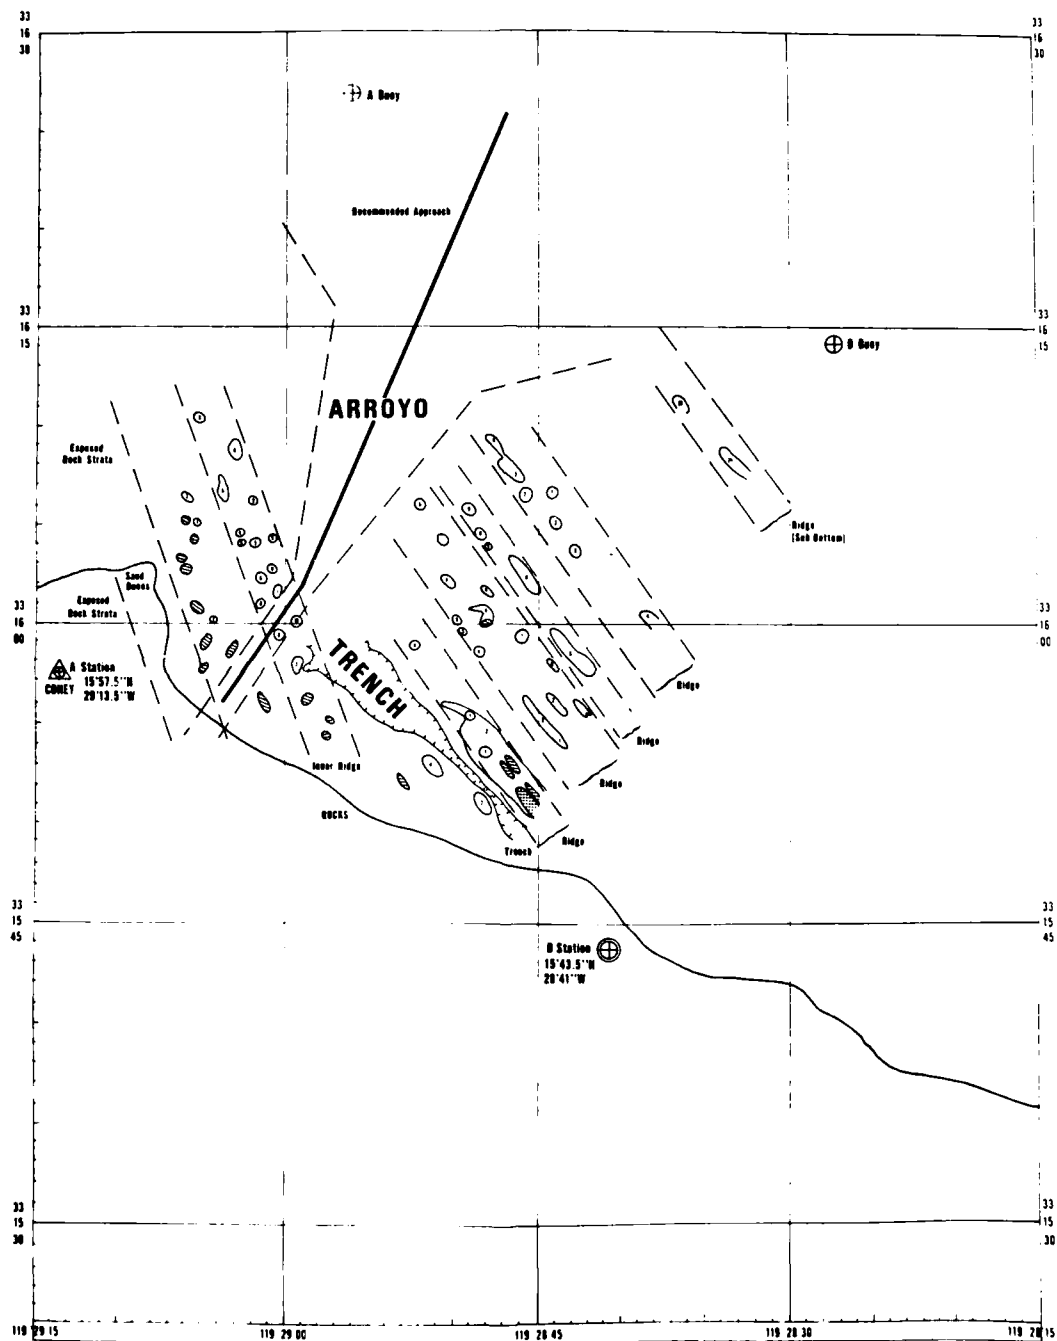
Figure 4. Rocky Feature Locations, With Minimum Depths

Submarine features identified during the course of the bathymetric survey of the YFU landing site on San Nicolas Island correspond directly to extensions of the visible landform ashore, and correlate with the geology of the Island. Essentially, a large ancient arroyo, which currently is the path of the road access to the beach from the mesa, continues out into the seabed. It is seen in the onshore contours in Figure 2, and its projection seaward is indicated. It is filled with sand in the beach area and in the offshore area. In the near shore, the sand exists to a depth of 4 to 6 feet in a loose condition, underlain by a somewhat consolidated material which stopped the diver's probing tool, but was not investigated further. The entire submarine feature, which represents a safe but narrow access route for the YFU, is shown in the bathymetric chart of Figure 3 (and the fold-out at the end of this report). It maintains a distinctive canyon like bathymetry, on a small scale, from the shore to the outer edge of the site survey area. The channel using this route is not straight. It has a small offset in direction some 800 feet from shore.

The steeply folded sandstone and siltstone rock formation visible on shore dipping downwards from the southeast to the northwest continues in the marine environment. Ridges are exposed above the low water east of the YFU landing beach. They dip northwestwards to present what appears to be isolated rocky features on the bottom west of the YFU landing beach. These features are actually prominences of the sub-bottom ridges. The aforementioned YFU access route via an ancient arroyo, eroded during a time of lower sea level, and now ponded with sand, lies between the rocky bottom features. All are visible in the bathymetric chart of Figure 3, the fold-out in the Appendix, and are further identified in the descriptive chart of Figure 4. The depths indicated in Figure 4 are minimum water depths at Mean Lower Low Water. The bathymetric chart is suitable for navigation and uses the Mean Lower Low Water (MLLW) as the chart datum. The tidal range at this site is almost 5 feet, with the mean tidal level 2.5 feet above the chart datum.

On the basis of this survey data, it is recommended that the range markers used in the approach of the YFU to the beach be replaced by a new set of markers, perhaps four, to establish a line close to the center of the submerged arroyo as shown in Figure 4. This alignment, with its dog leg offset, offers a safer distance for the YFU from the submerged obstructions.

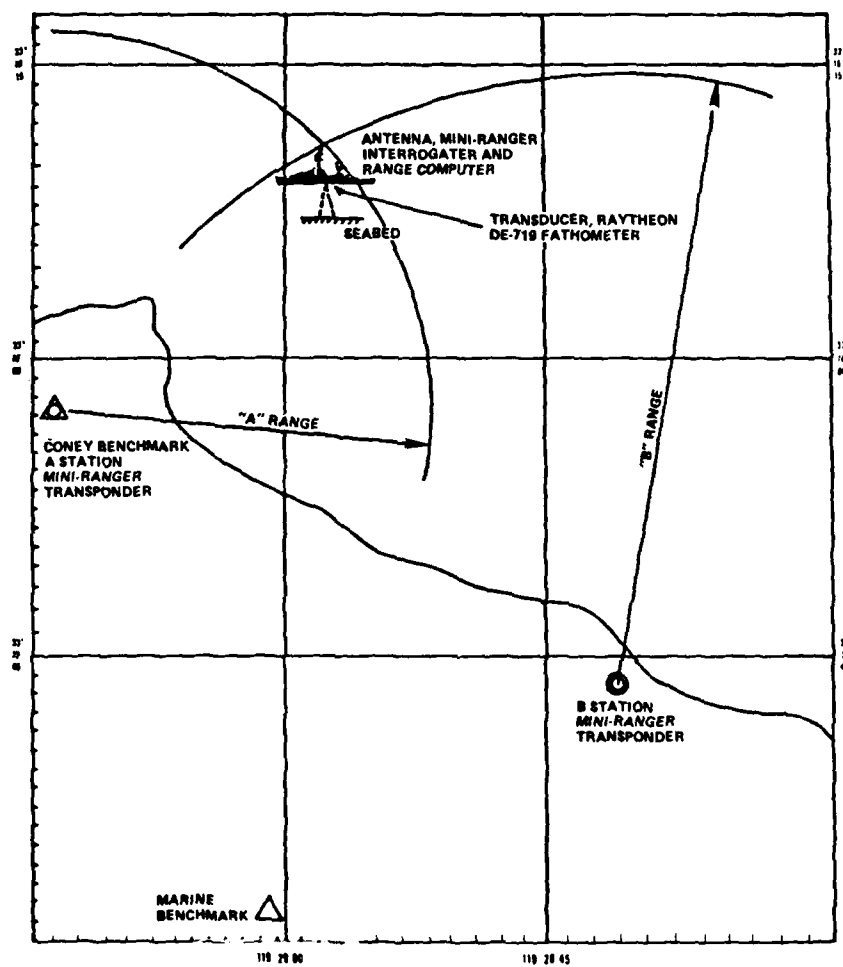
Figure 6: Block Diagram, Survey System Showing Location of Mini-Ranger Transponder Stations on Shore.

①
p. 20; 21 # 4.1 refers to Block
Diagram per title of Fig. 6,
however, fig. 6 is not a "block"
diagram. Fig. 6 is an operational
drawing showing relative physical
position of survey system compo-
nents.

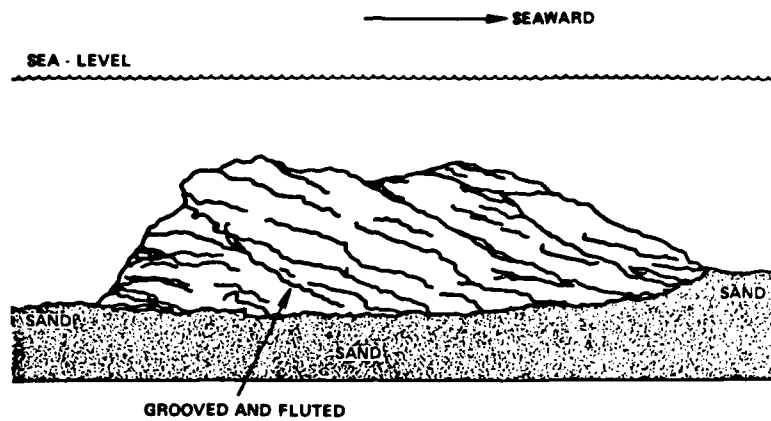
Figure 11. Diver Sketch Of A Rocky Feature (Seaward Side)

"The rock ridge at this location extends 130 feet in an east-west direction and is about 45 feet across the widest area. Approaching the

ridge from seaward, the rock formation rises rapidly from a depth of 19 feet to a rugged ridge varying from 7 to 9 feet deep. The water depth increases to 16 feet on the inshore side of the ridge. A length of steel anchor chain was observed on top of the ridge. This may be part of the missing channel buoy mooring."

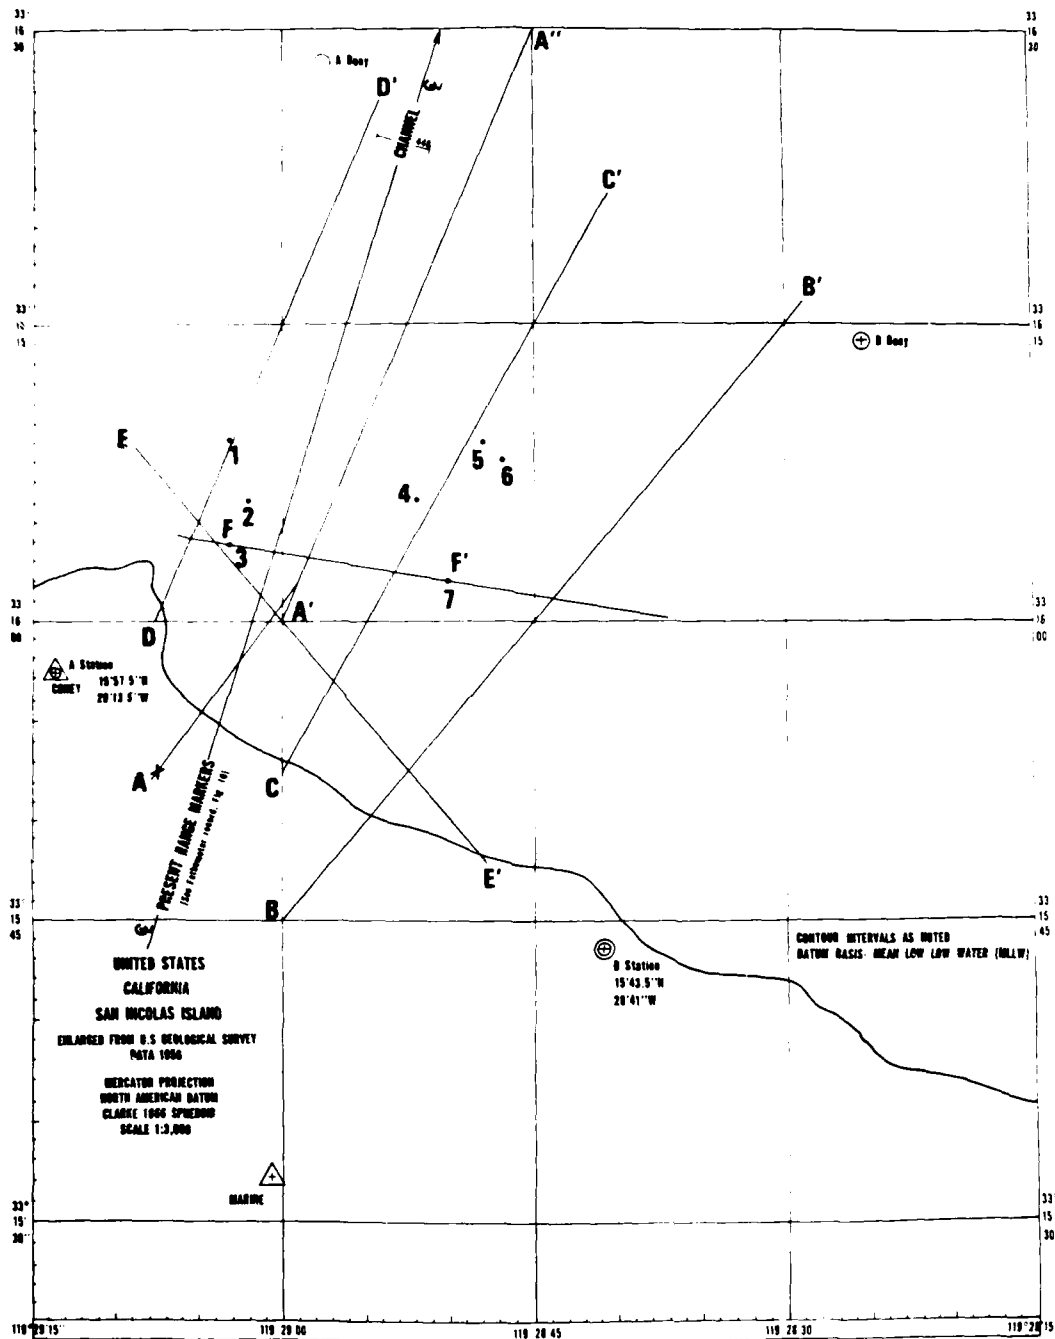
Figure 13. Chart Showing Locations Of The Bottom Profiles

②
p. 31. I can't readily see the 7 loca-
tions discussed on p. 31 ff when I
examine the referenced Fig. 7.
Just found it. I think that figure
13 is the drawing ^{to which} one should be
directed in line 2 of 2nd ¶ of
p. 31.
